## 1. INTRODUCTION

#### 2. STORMWATER CATCHBASIN INSERTS

### 3. STORMWATER INSERT EVALUATION

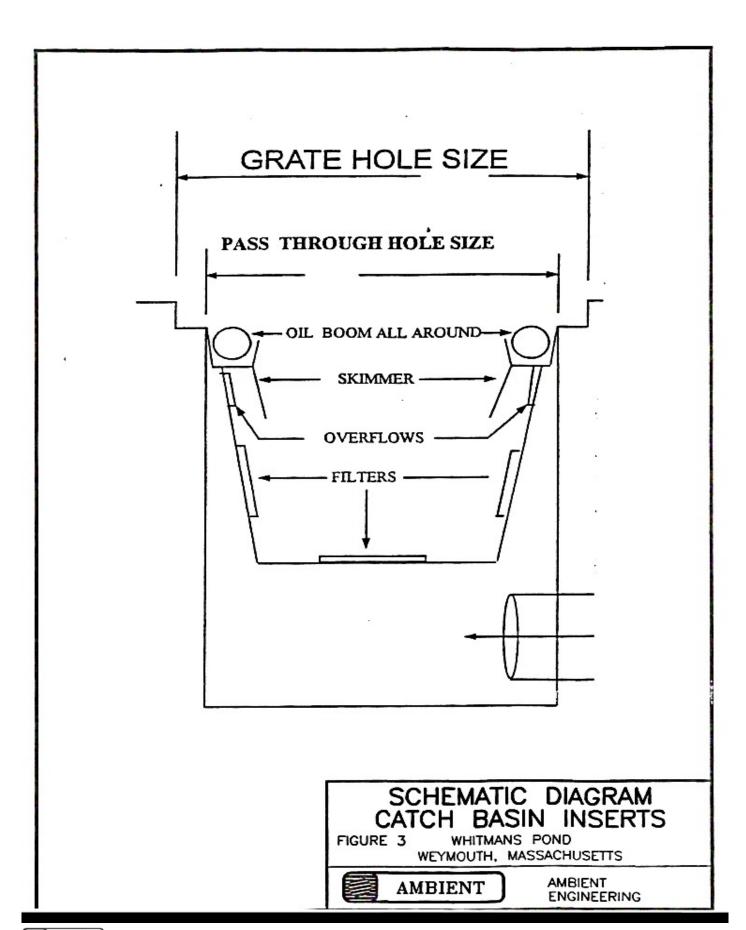
The recommended insert is called the Grate Inlet Skimmer and is manufactured to order by Suntree Isles Inc. of Cape Canaveral Florida. These units are sturdy, light, and collect petroleum runoff using an oil boom. Compared to other inserts, they trap a large volume of sediment. As with all such devises, periodic cleaning is required according to the rate of sediment deposition. The maintenance requirement was low, and the insert was designed to allow stormwater to bypass the filters if the basin was filled. A schematic diagram of the Grate Box Skimmer is provided in Figure 3.

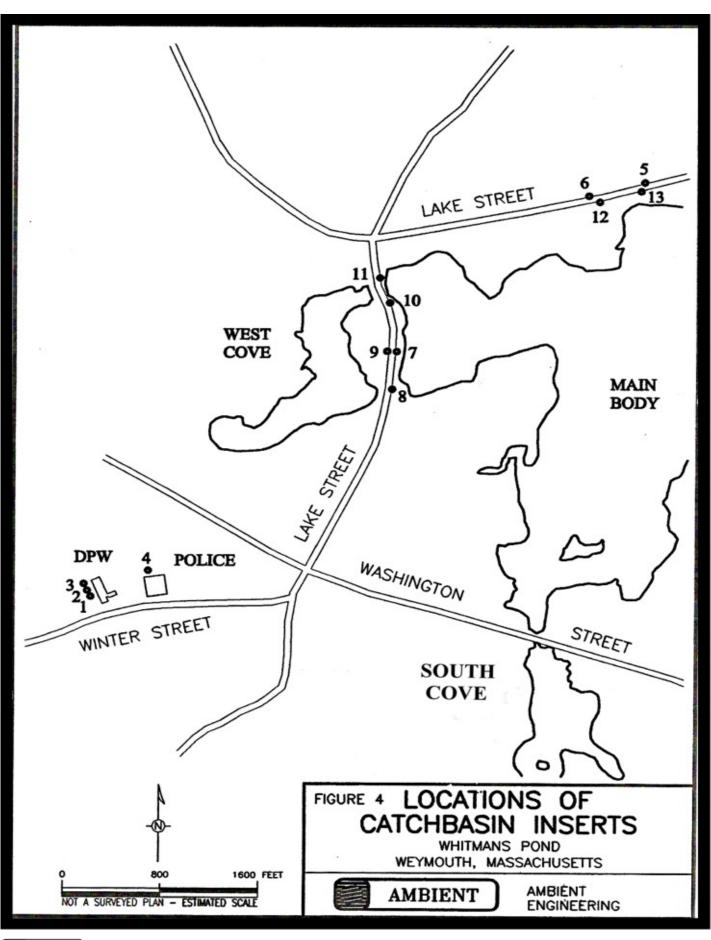
The location of stormdrains entering Whitman's pond are shown in Figure 2. The location of 13 stormdrains where inserts were installed are shown in Figure 4. These catchbasins were originally given letter designations, but were later given numerical designations by the Department of Public Works.
