CASE STUDY

Volume 8
Number 4
November 2005

C125 BioNet Blankets & Bioengineering Techniques Restore River Banks in Nashville, Tennessee

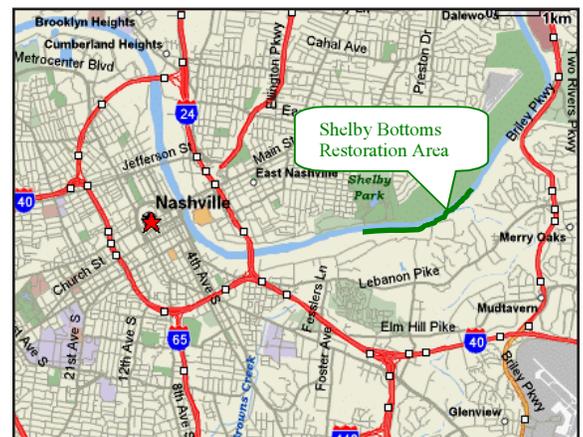
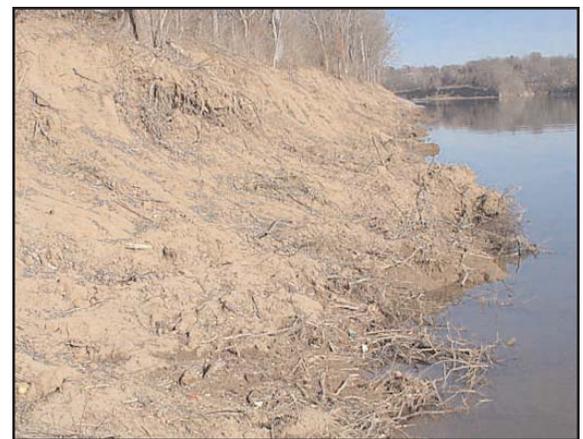
Eroded banks along the Cumberland River are unsightly and pollute the waterway.

The slopes along the river had become steep and badly eroded. Trees were falling into the river because of the large amount of soil missing from around their roots. An entire mile of shoreline had been eroded to nearly a vertical gradient by waves generated by wind, river taxis, barges, and large boats, as well as fluctuations in the river level following strong storms. It was obvious that large amounts of soil would be needed to reconstruct the bank and that this new soil must be protected immediately and permanently. However, due to the location, no mechanized equipment could gain access to the shoreline.

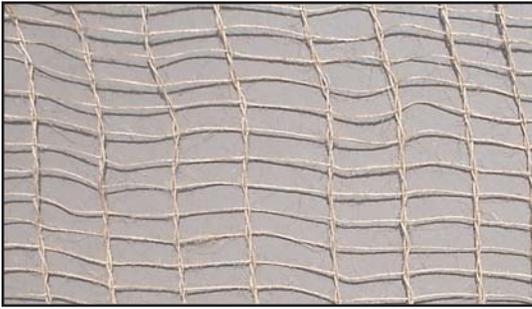
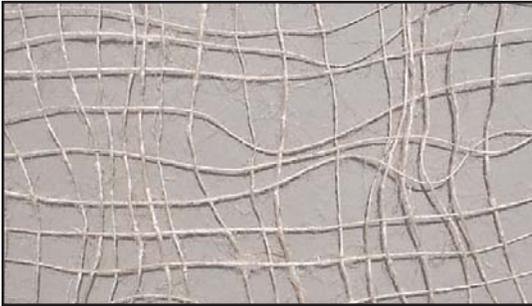
Leno woven nets (above) feature double twisted strands in the machine direction that provide higher strength and integrity to the BioNet blankets than that of cross-lay nets (below).

between two jute nets. Coconut fiber gives the C125BN exceptional soil coverage for superior erosion control and good moisture retention at the soil surface for quick seed germination. The top net features a "Leno" weave that enhances the blanket's strength and erosion resistance while reducing the risk of wildlife entanglement as compared to cross-lay nets. This construction allows the C125BN to function for up to 24 months.

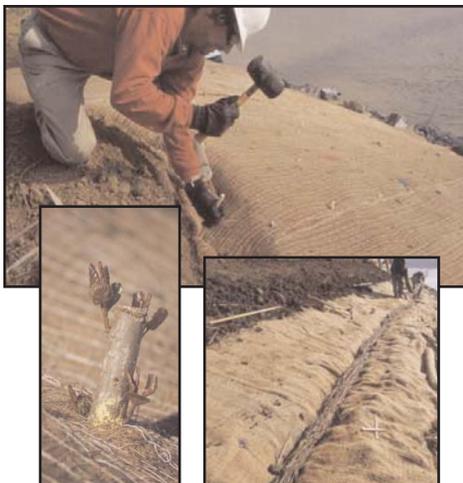
Installation of the C125BN (top) included an anchor trench at the top and hardwood EcoSTAKEs to secure the blanket. Fascines are placed in a trench on top of the blanket (right), and live stakes (left) begin to sprout leaves in only a few weeks.

Before installation of the C125BN, the river bank was regraded to a gradient of nearly 1:1 (H:V), followed by an application of seed. C125BN was then applied to protect the newly seeded slope. In keeping with the natural design of the project, North American Green's 6 and 12 inch long wooden EcoSTAKEs™ were used to secure the C125BN. Live plants were then placed through the blanket or cradled by the blanket using the plurality of techniques mentioned above. Installation of all blanket and plant materials started February 1st 2000 and was completed on April 8th, 2000.

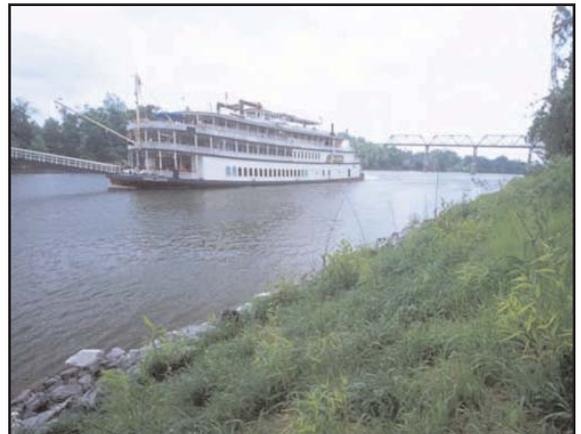
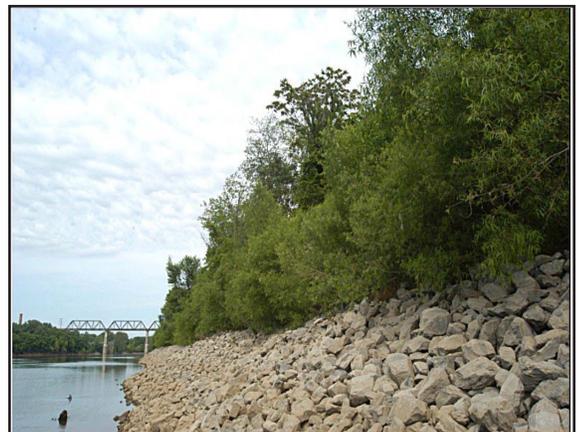
Intensive maintenance encouraged vegetation to become well established within one month (above), and fully established within three months (below).

Jen-Hill Construction Materials followed a strict schedule of watering the newly installed plantings by pumping water from the river and spraying it onto the bank from a boat at a rate of 27,000 gallons per acre per week. Such intensive watering was necessary to quickly establish the live plants and ensure a high survival rate. This was indeed the case as the live plantings and grass began to establish, resulting in very well established vegetation by the end of June.
