CONFINEMENT SYSTEM OFFERS STABILIZING OPTIONS FOR

Shoreline Restoration

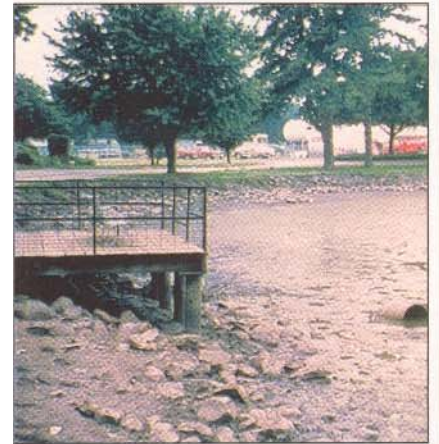
Years of sediment buildup from shoreline erosion, however, had caused the once beautiful focal point to become an eyesore of muddy, stagnant water. The town was challenged with having to restore the pond

- 1) The stabilized shoreline is infilled with vegetation in the upper portion and concrete in the lower portion exposed to water contact.
- 2) Years of sediment buildup and erosion had made the city pond an eyesore.
- 3) The pond was drained and dredged, removing sediment and large amounts of accumulated rock.
- 4) The Geoweb shoreline protection system was expanded and positioned longitudinally on the perimeter slopes.
