The GEOWEB® Slope Protection System Permeable Stabilization for Embankments Case Study Summary 1

CASE STUDY 1: Castle Rock, Washington October 2000

Washington Metropolitan Area Transit Authority (WMATA)
Southern Ave. Station, Washington, D.C., August 2000

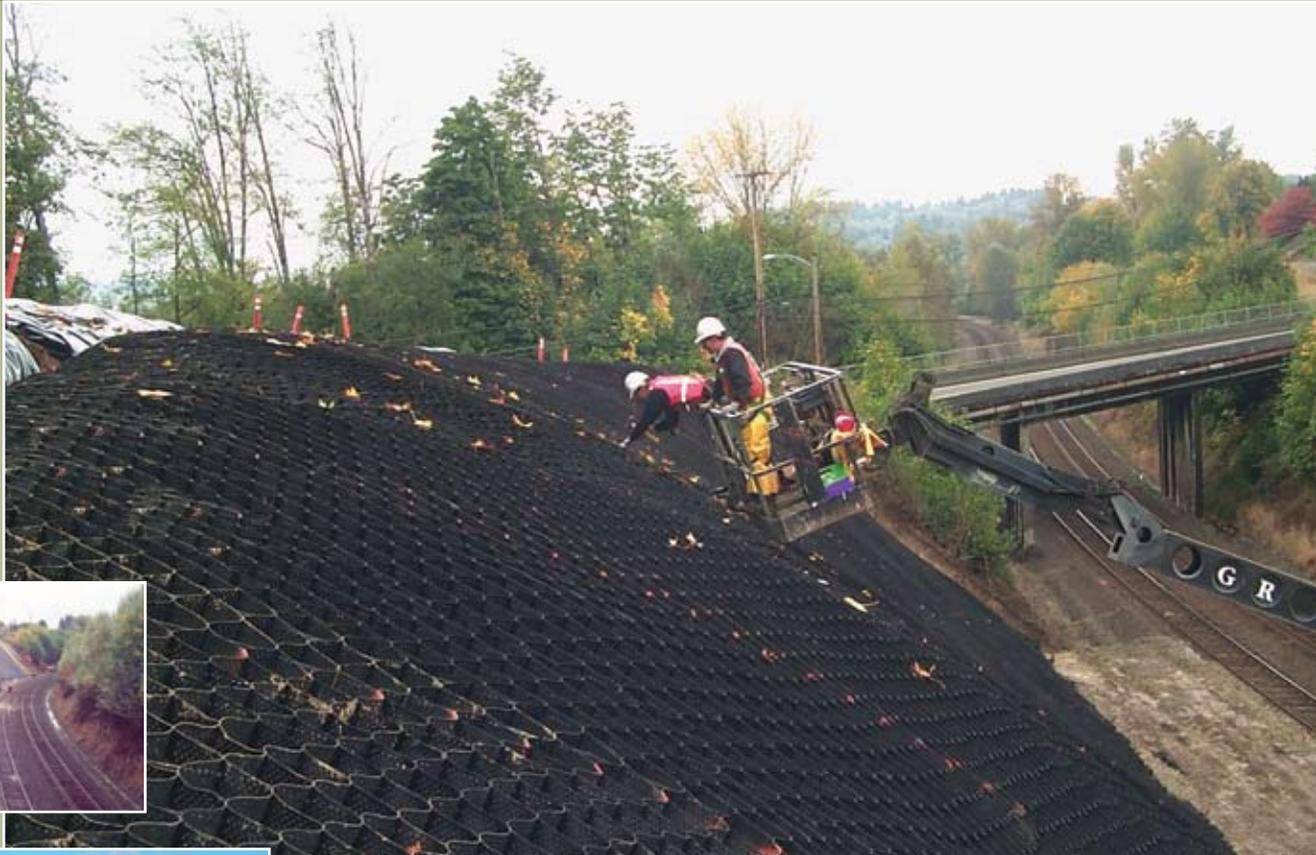
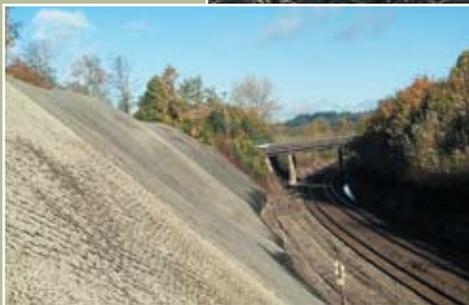
A spider excavator was utilized to repair and finish-grade the slope face prior to placement of the nonwoven geotextile and Geoweb® materials. Eighty-foot mobile manlift units were employed so construction crews could staple tendoned Geoweb sections together and position and drive anchor stakes. Aggregate was placed in the sections using a concrete conveyor with a 100-foot boom.

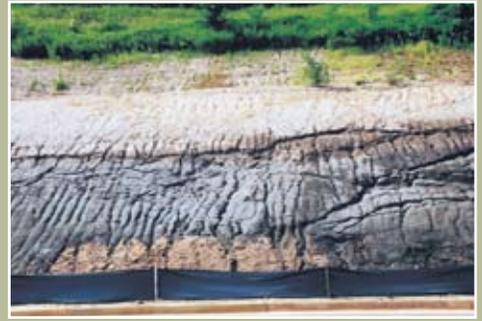
The perforated Geoweb® system with aggregate infill placed over a geomembrane and a catch drain system at the toe of the slope provided the best solution.

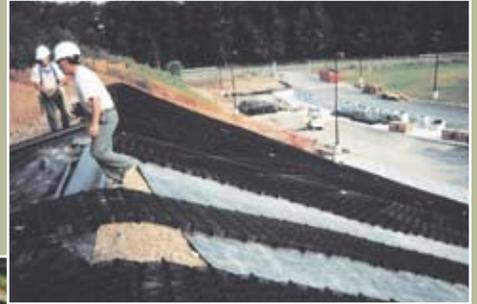
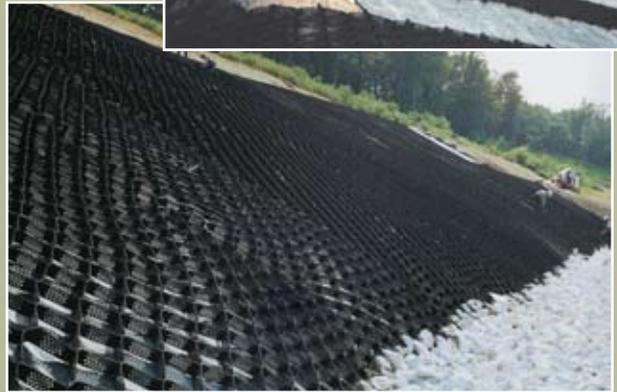
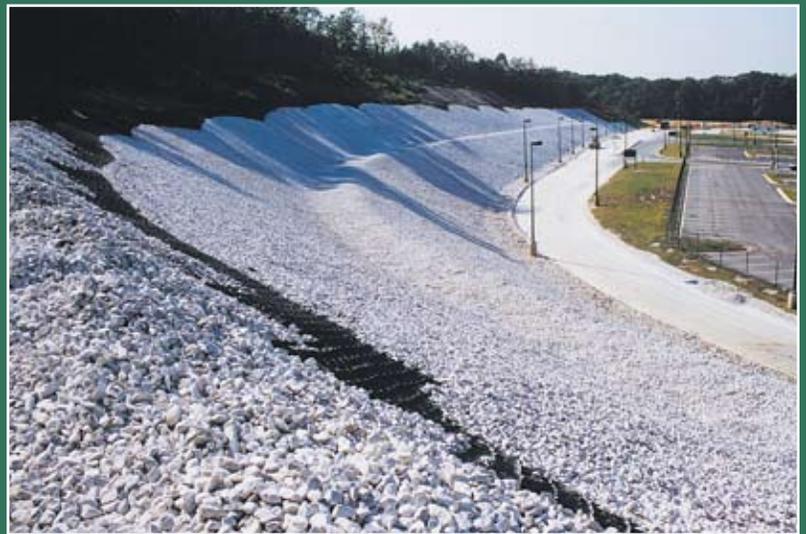
Workers used harnesses and safety tether lines anchored at the crest of the slope to install the liner and Geoweb sections on the embankment. Glass-fiber ATRA® anchors, chosen for their corrosion-resistance, were used to secure the Geoweb sections. Holes created in the liner by these anchors allowed acceptable groundwater drainage to occur from underneath the slope protection system.

The permeability of the aggregate-filled Geoweb system over a geomembrane created a cover that prevents surface erosion while creating a stable surface watershed. This solution provided resistance to heavy rainfall events, while allowing drainage of the embankment soils through the overlapped sections of the impermeable liner.
