Applied Polymer Systems, Inc.

Clover Bar Ravine Clean Up, Edmonton, Alberta

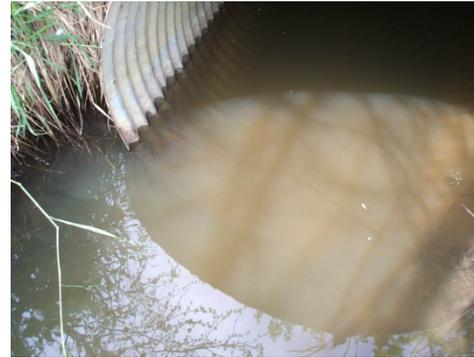
Left: Water before treatment with Floc Logs.

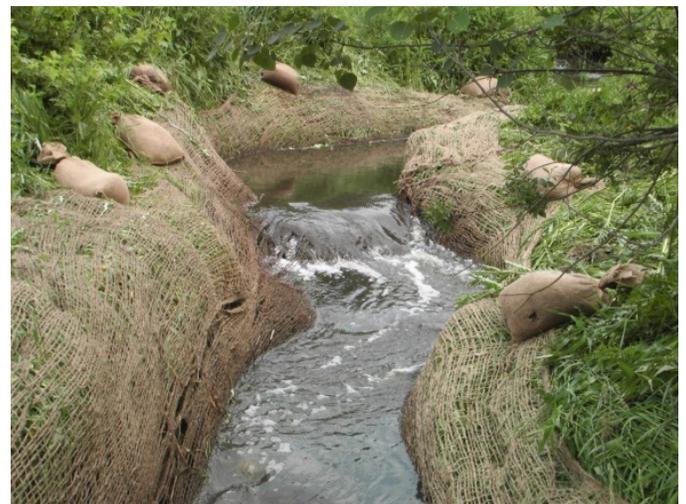
Below: Jute matting was installed along the stream bed and banks.

The passive treatment system was installed in June 2007. The treatment system was designed with 34 Floc Logs® placed along the creek bed beginning at the outfall. Before the logs were installed, the streambed was lined with an open-weave jute matting to prevent further erosion and work as an area of attachment for flocculated particulate. The logs were placed 10 feet apart alternating between APS 703d#3 and 706b Floc Logs®. Sand bags were placed in the channel and the Floc Logs® were tied off to them. The sand bags kept the logs in place as well as increased the turbulence of the water flowing over and around the logs, increasing mixing which in turn improved the reaction and performance of the system. The only maintenance required for this passive treatment system was simple monitoring of the banks to ensure they were not washing out. The biodegradable jute matting was not removed; new layers were simply applied directly on top of existing layers.

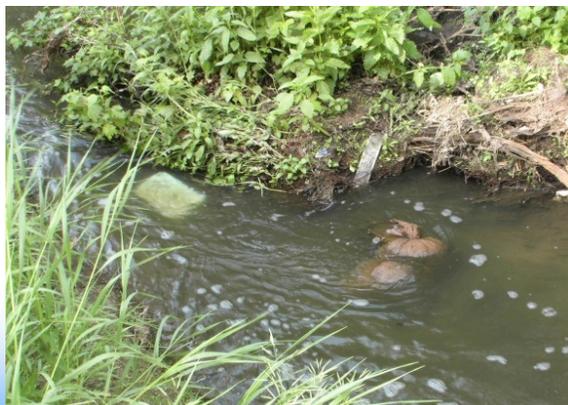
Left: Floc Logs were attached to sand bags, which added extra turbulence.

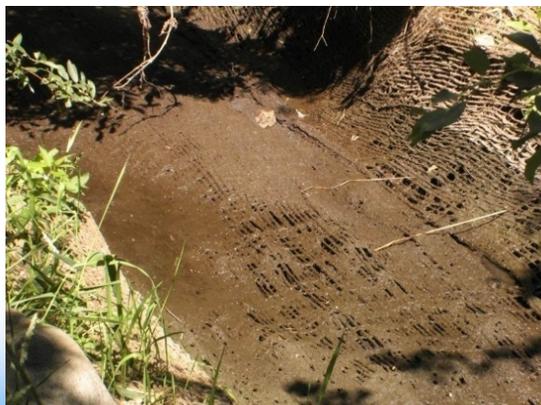
Right: Jute lining the creek bed and banks captured flocculated metals and sediment, preventing them from discharging into the stream and river.

These flocs are heavy and settle quickly out of the water column. Natural fiber matting, such as jute, is used in conjunction with Floc Logs® to provide an area of attachment for the polymer charged particles as well as added erosion control. Floc Logs® are composed of anionic, negatively charged, polyacrylamides. This charge repels against the negatively charged gill mucous of fish and other aquatic organisms, making them nontoxic even at high dosages and safe for use in the open aquatic environment, unlike cationic (positively charged) polyacrylamides or chitosan that can cause detrimental effects to aquatic organisms.

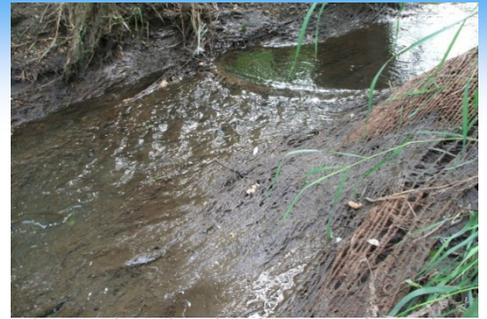
Above: Flocculated sediment and metals attached to jute matting result in clear water discharging from the treatment train.

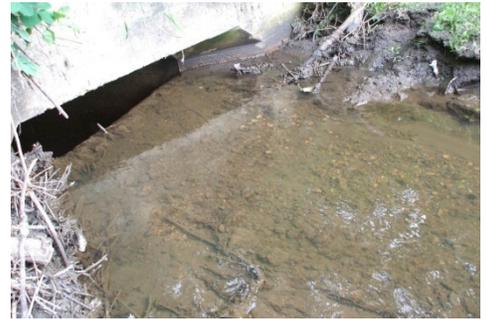
Above: Success is evident with clear water exiting.

Analysis of the water samples taken during treatment years showed a clear reduction in metals as well as total suspended solids (TSS) after the Floc Log system was installed. Water collected downstream from the treatment system showed dramatic reductions in TSS levels. Sampling revealed TSS levels as low as 4 mg/L and clear visibility to the bottom of the stream. Large concentrations of collected sediment were observed within the treatment system and sediment samples from the first site showed large concentrations of metals within sediment that had accumulated around the Floc Logs®. There was then a gradual decrease in metal concentrations moving further downstream in the treatment system. The passive treatment system achieved turbidity levels and metal concentrations limits that were established by the regulatory agencies. These results are proof positive that the implementation of the polymer enhanced passive treatment system was highly successful and the eco-friendly solution to reducing turbidity and metal contamination within the Clover Bar Ravine.
