# Innovations

## The Croft Pond at the Nashville Zoo

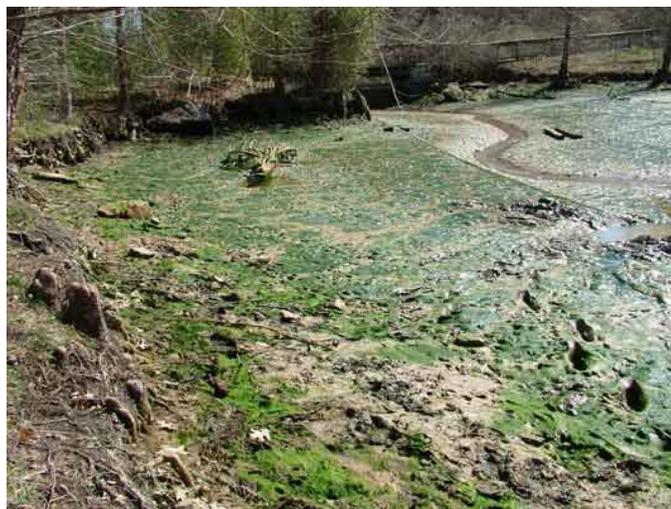
Croft Pond, once drained revealed 8 feet of sediment.

But before repairs could be made, the sediment needed to be removed. However, the soupy mess that was left at the bottom of the pond would be extremely difficult to remove with conventional methods. It was estimated that there was 7000 tons of sediment to be removed, covered by 3 feet of water. Kevin Surprise, of 5K Construction, found that large excavating equipment could not be used, as there was limited access to the pond due to the zoo's surrounding walkways.

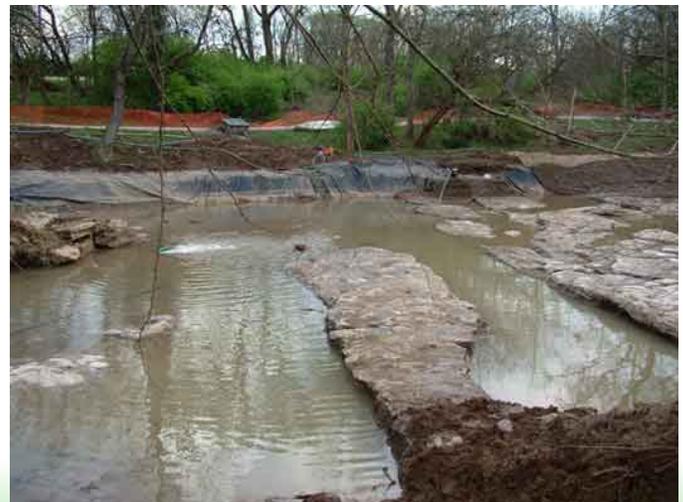
Even the small trackhoe that was brought in and placed on the bank had trouble. Between the muskrat activity along the banks, and the large crevices in the concrete bottom of the pond, it was too unstable to operate safely.

The uneven terrain provided a challenge to the machinery.

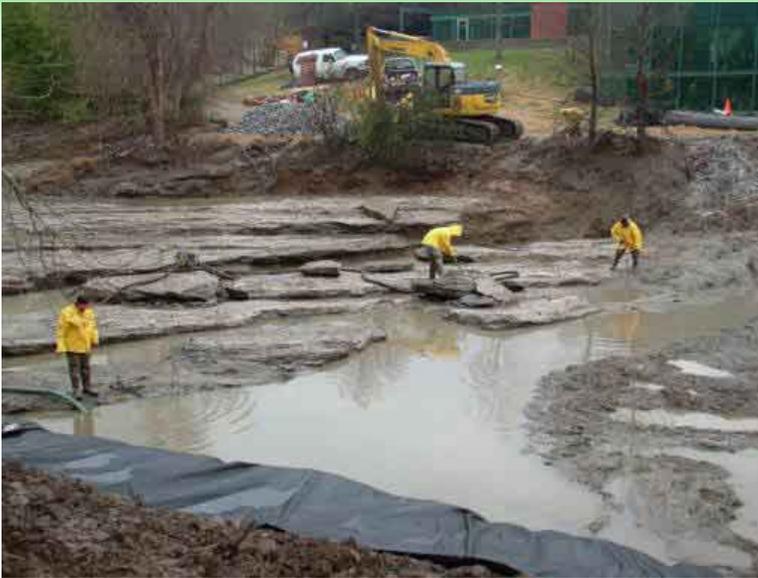
**Pumping off of excess water to expose the sediment before removal.**

To start, the upstream water was re-routed back into a wetland through the Zoo's pumping system, effectively creating a zero-flow environment at the pond site. Each day the pumps were started early and the clean water discharged over the Floc Logs to remove the suspended solids before diversion into a stormwater detention area, built with Jen-Hill flex max gabions, that had been constructed previously as part of the requirements for the Elephant exhibit. Floc Logs were also used to stabilize the spring-fed stream pouring the organic materials into the Croft Pond, as well as the stormwater ditch flowing into the site.

After 2 hours of dewatering each morning, sediment removal would begin on the areas isolated and stabilized using APS Silt Stop powder the afternoon before.

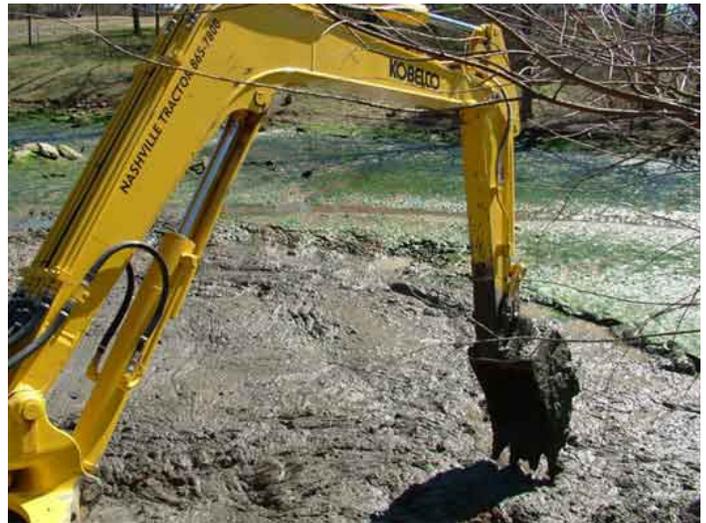
**APS Silt Stop solidified the sediment for easier removal.**

Because of these limitations, Gary Moody decided to use Applied Polymer System's Silt Stop and Floc Log products. He had worked with these products before, and was familiar with their superior performance. Since APS's polymer products are matched to the specific lithology of each site they are used at, Gary sent soil and water samples to the APS testing lab to match the PAM blend to the site.

For this project, 250 pounds of APS 705 & 712 Silt Stop powders were used, along with 8 APS 703d Floc Logs. The project cost over \$130,000 and took 28 days to complete while the zoo remained open. This saved the zoo a fortune, as there was realistically no other way to do the project between the constraints of the limited access to the site, and keeping the rest of the zoo fully operational.

Occasionally the Silt Stop powder was added directly to the water surface and then mixed into the water and underlying soils by submerging a pump nozzle into the water and soils beneath thus solidifying the soils for removal. Once the muck had solidified, it could be easily scooped up and transferred into a single-axle dump truck and hauled away.

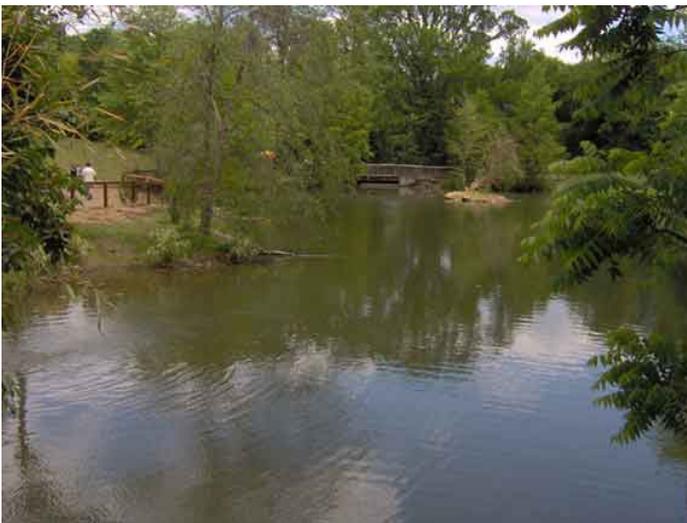
**Project Complete: Croft Pond, fully restored.**

After the sediment was removed, an island was constructed for the birds. Repairs to the dam were made with the GSE Polylock and a geo-membrane. This barrier prevents the pond from accidentally draining again, and protects the water from further off-site contaminates. Re-vegetation of the exhibit, overseen by Kelly Flora and Ben Moody, used native Riparian plants, special grasses, and wetland sod grown by Jen-Hill. The project was completed on time and on budget, allowing the pond to reopen as the new Black Neck Swan exhibit.
