Rehabilitation of Raw Water Reservoir for Franklin WTP

by Bill Shehane, P.E.

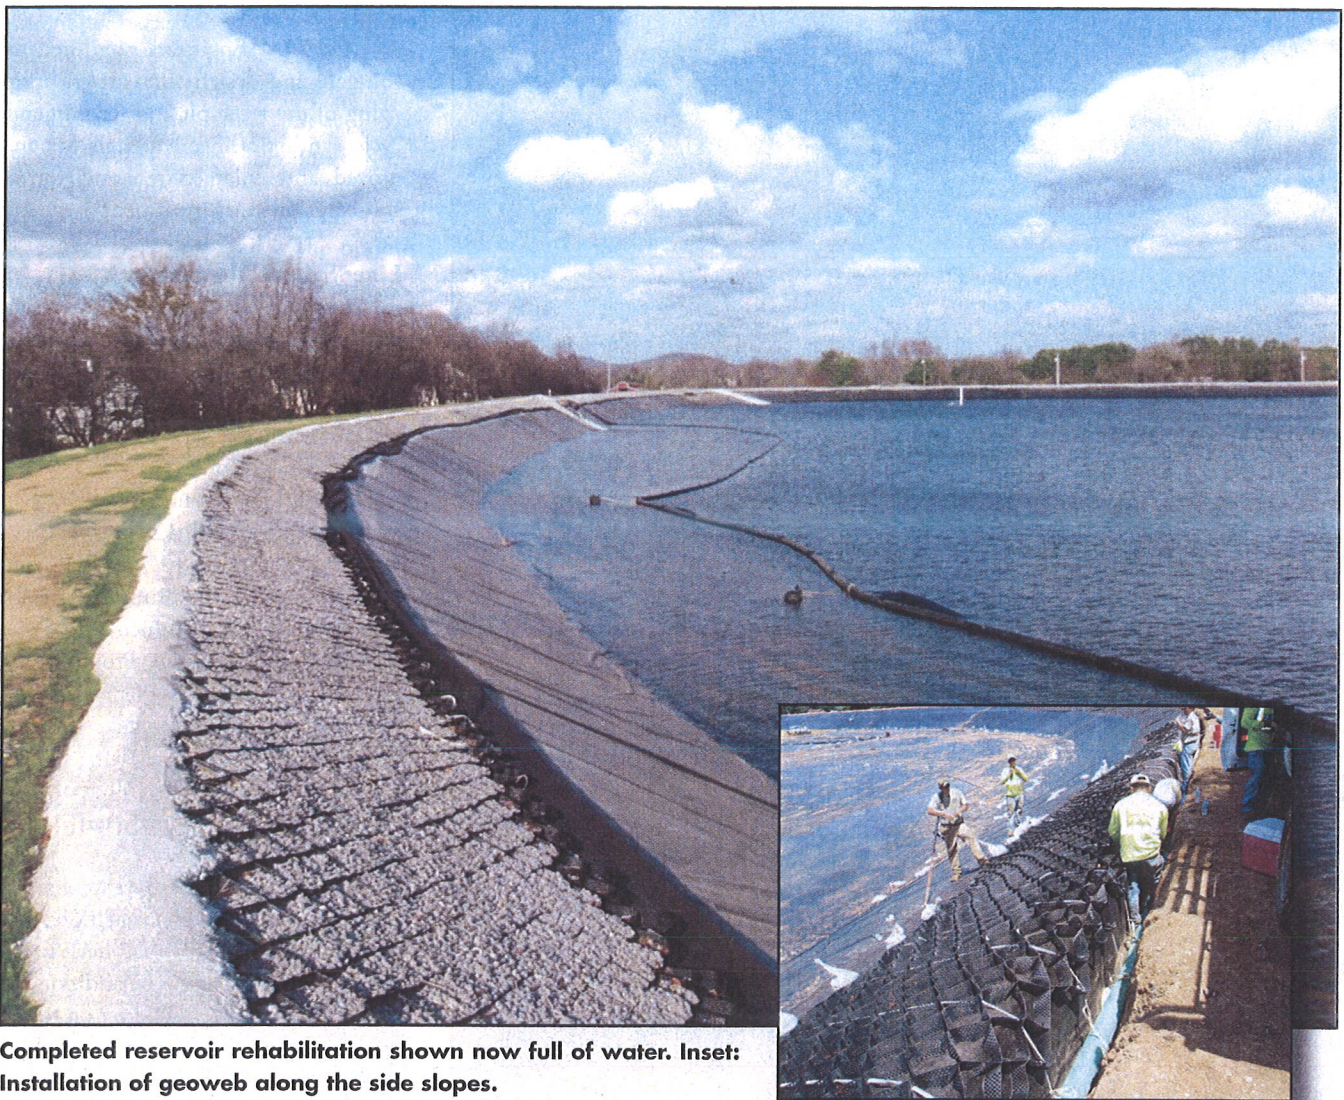
Completed reservoir rehabilitation shown now full of water. Inset: Installation of geoweb along the side slopes.

Due to concerns from potential wave action when the reservoir is full of water, AECOM recommended a geoweb with stone be installed along the top of the side slopes and on top of the geomembrane liner. After the geoweb was in place, a concrete anchor trench was installed. The geoweb with stone was also placed below the 24" influent pipe to prevent scouring and as a ramp down to the toe of slope for vehicle access when needed.

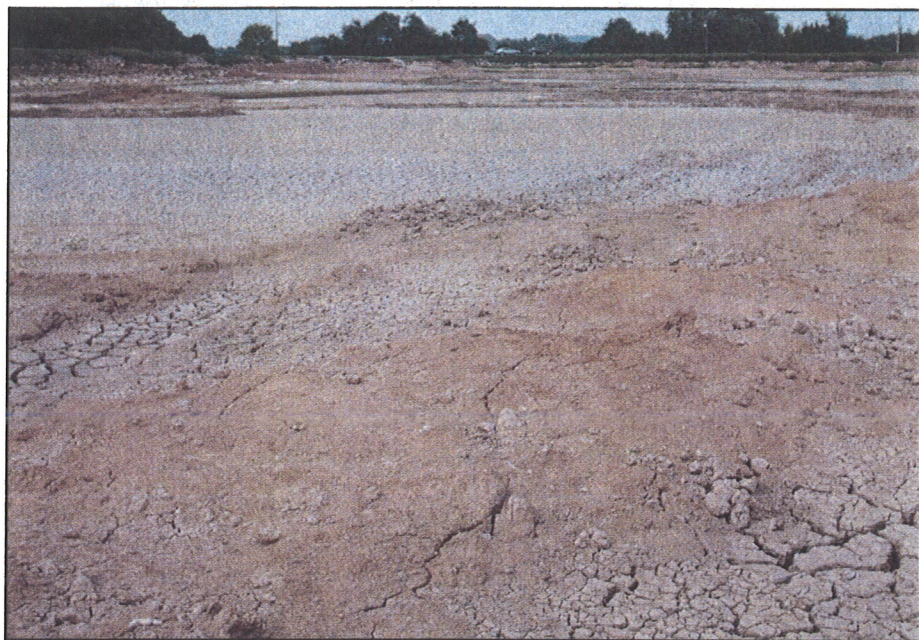
Top: Reservoir in 2008 after the major drought of 2007. Below: Disposal of filter backwash solids.

Another means of increasing the capacity of the reservoir was removal of the existing filter backwash solids. There was a significant volume of material due to over four decades of use, with the solids now being diverted to the sanitary system. The filter backwash solids had high levels of aluminum and copper and was considered a "special waste" if taken outside the reservoir, since it was processed. The options were as follows:

The option chosen was to haul the filter backwash solids to a C+D landfill, which required 1,900 dump truck loads or a total of 33,000 cubic yards.

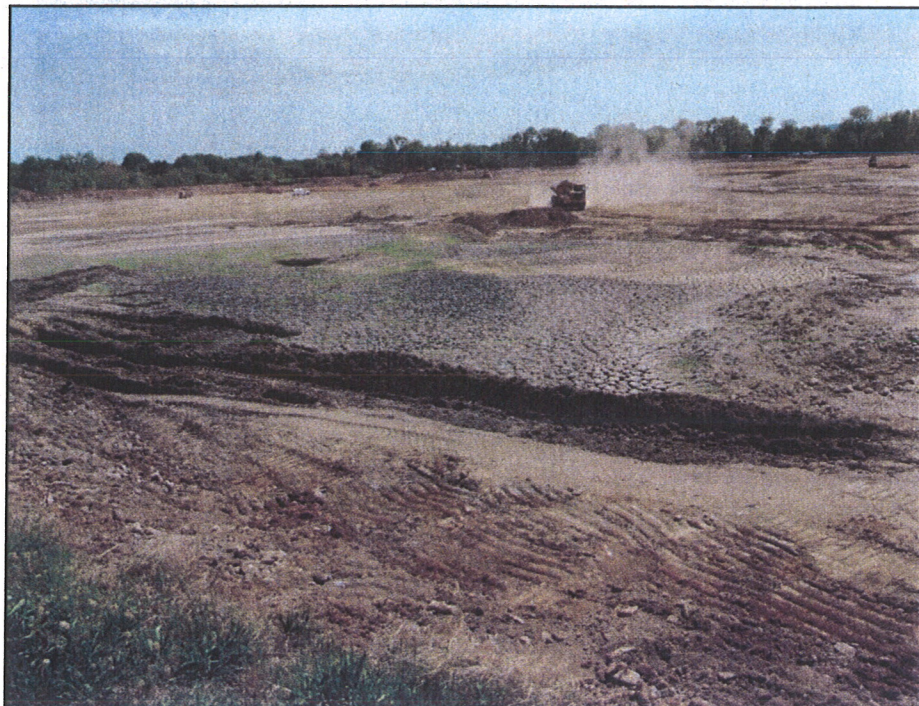
AECOM looked at seven alternatives to increase the overall capacity of the reservoir from 80 million gallons to a potential 155 million gallons (see Figure 2). With a combination of raising the spillway 2 feet, raising the berm 8 inches and excavating soil in the bottom, the optimum design volume came to be 105 million gallons (Alternate D). This was based on the estimated grading and modifications cost at \$250,000 and only 1,500 yards of excavation required.

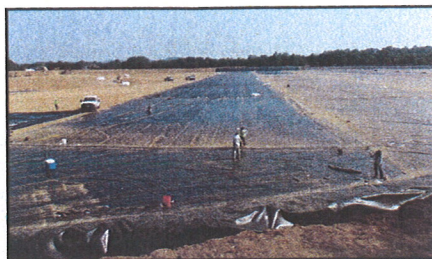
Geomembrane liner installation.

Even though the reservoir will be holding "raw water" from the Harpeth River, the facility owner wanted the liner system to be NSF 61 certified for potable water. After one month of fine grading the reservoir bottom, installation of the geomembrane liner started. Since the geomembrane was a heavily reinforced coated fabric with excellent physical properties such as puncture resistance, a geotextile below the liner was not needed.

The EIA-R was prefabricated into panels 90 feet wide by 180 feet long (16,200 SF each). Fabrication of the geomembrane was performed by Colorado Lining International's New Caney, TX facility and installation of liner and geoweb was by Geosynthetics, Inc. (GSI). A total of 95 prefabricated geomembrane panels were delivered to the job site. This allowed for only 2 field seams per acre required, which dramatically reduced the amount of CQA testing in the field.

A thicker 45-mil reinforced EIA-R was installed on the side slopes since they will experience greater exposure to the elements and a 36-mil reinforced EIA-R was installed on the reservoir bottom. Liner in-

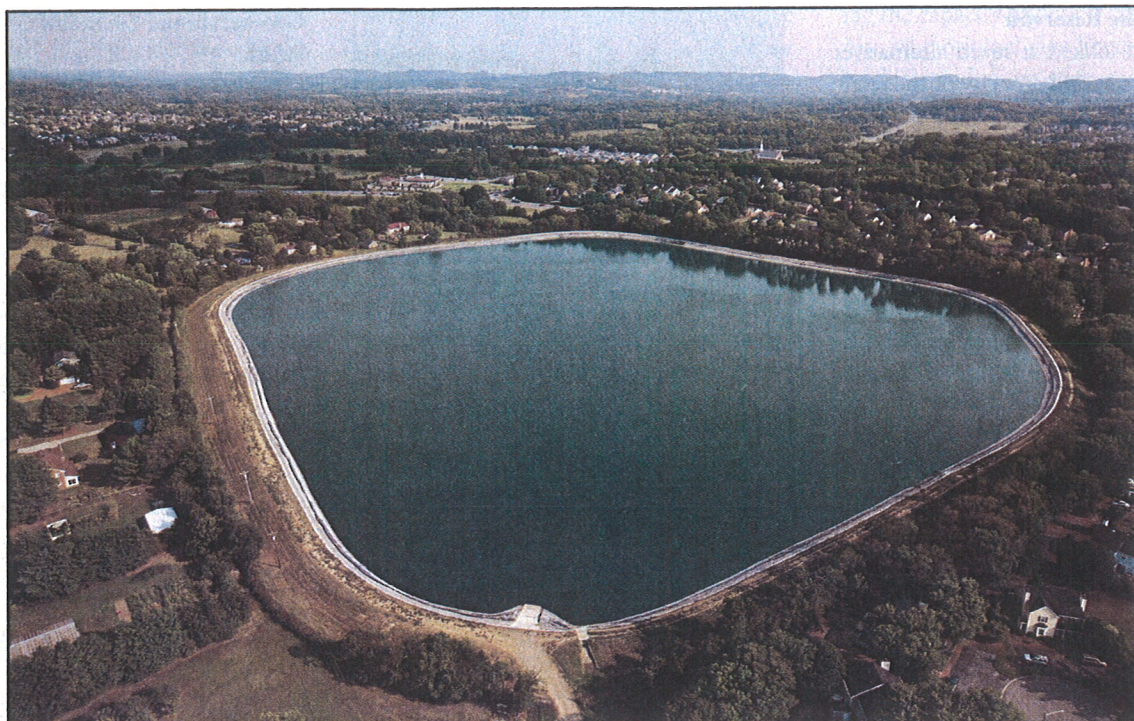
Aerial photo of the completed reservoir.

on April 1, 2010. The reservoir was operationally complete in October of 2010, with the final construction cost being over budget by only 1% (\$3,946,762). The general contractor was Summit Construction based out of Nashville, TN. Once completed, the reservoir achieved a total of 113 million gallons of storage which was 8% over the original design of 105 million gallons.
