# **GEOWEB**® NATURALLY VEGETATED SLOPE SOLUTIONS

**American Tobacco Trail Slope**

# STABILIZING A MULTI-USE TRAIL'S RIGHT-OF-WAY EMBANKMENT

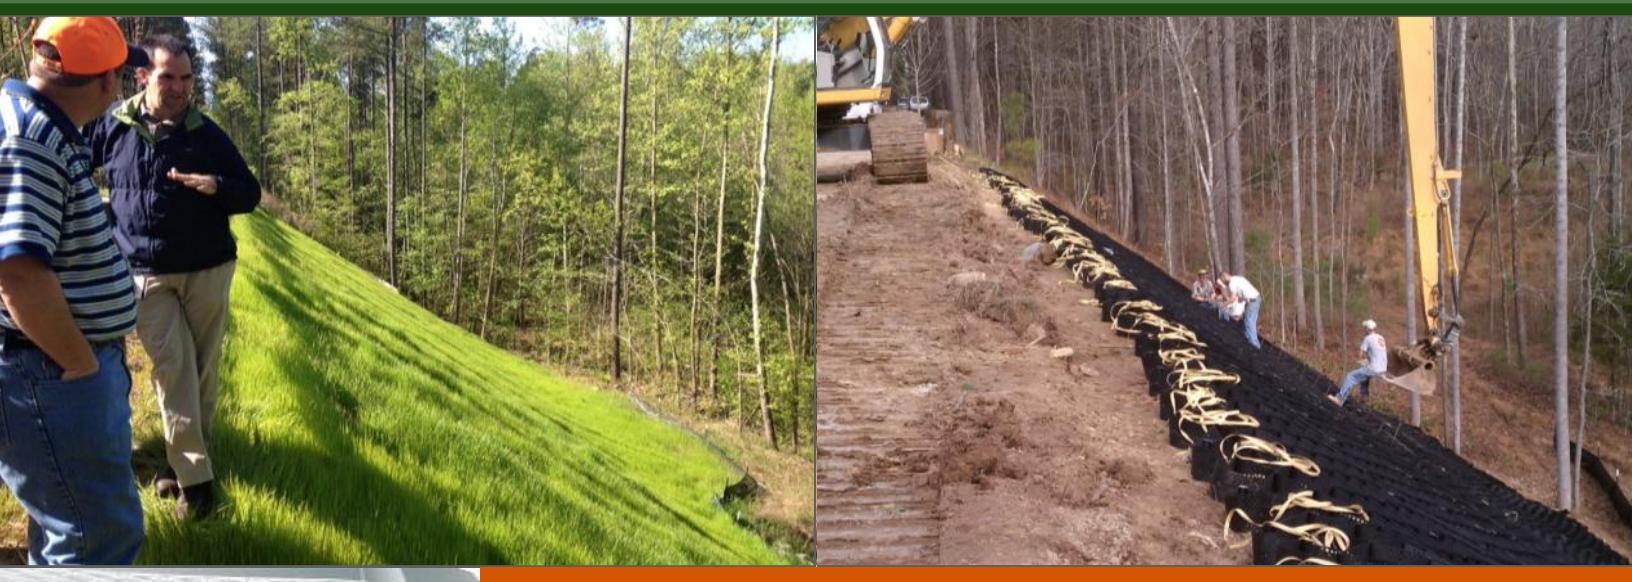
GEOWEB<sup>®</sup> system with tendons every 3-cells expanded down the slope.

McQueen Construction installed the GEOWEB slope system with tendons anchored in a trench at the crest along with 3 ft rebar anchors to stabilize the failing steep slope in a 45-day project at the end of 2011. The cell wall slots in the GEOWEB system allowed quick threading of tendons and connection of sections with ATRA® Keys, a quicker alternative to stapling.

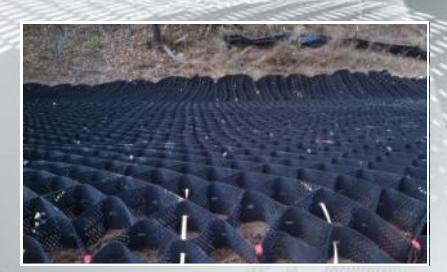
Left photo : A tendon and ATRA® load transfer clip are passed through the GEOWEB® cells.
