PROTECTING THE Bluff

AN INTEGRATED EROSION CONTROL DESIGN STABILIZES LAKE MICHIGAN'S SHORE.

BY JILL PACK

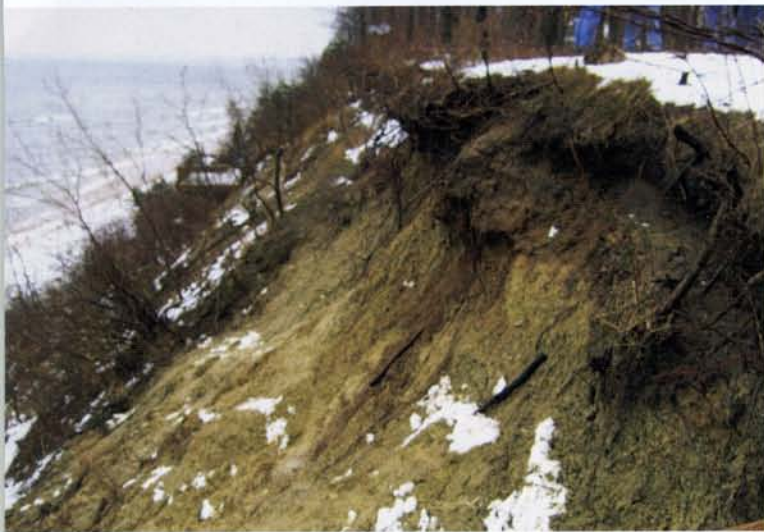
The steep bluff embankment along Lake Michigan's shore experienced excessive erosion but was stabilized with an integrated design to control the water flows.

The team chose a Presto Geosystems Geoweb cellular confinement system for slope stability on the upper portion of the slope. The system was selected to improve the performance and stability of the 3–4 inches of soil fill that was applied to fix the grade of the embankment. The perforations in the cellular confinement system allowed for lateral drainage through the system, thereby enhancing the performance of the system in the saturated soil conditions expected onsite.

Within weeks of the project's completion, the native seed mix was returning the bluff to a natural vegetated condition.

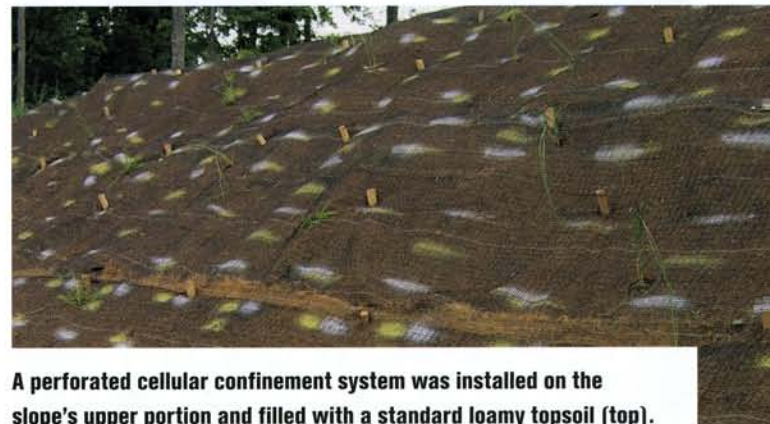
A perforated cellular confinement system was installed on the slope’s upper portion and filled with a standard loamy topsoil (top). The area was then seeded and protected with a coconut-filled turf reinforcement mat (bottom).

To prevent surface soil erosion from the confinement system and to help reinforce the establishing vegetation from runoff water, the team chose to use a C350 Composite-Turf Reinforcement Mat (C-TRM) manufactured by North American Green. The C-TRM’s three-dimensional permanent netting structure combined with a coconut fiber matrix had the benefits of both an erosion control blanket and permanent matting for temporary and permanent protection.

Equipment onsite was limited to a Bobcat skid-steer loader and a small excavator, but the crew managed to complete the work, cutting back the near vertical upper portion of the slope to a 1:1 slope. The crew then installed the cellular confinement system on this portion of the slope and anchored it at the leading edge in a small concrete trench, topping it off with a standard loamy topsoil fill.

After prepping the upper portion of the slope, the crew seeded the area and installed the C-TRM overtop. They then tiered the remainder of the slope every 8 to 10 feet, creating 4- to 5-foot-wide benches. The SedimentSTOP rolls were used to help create the tiered benches, as well as to protect the edges of the tiers while the turf reinforcement mat was installed on the top face of the tiered benches. The Lake Michigan bluff project—originally

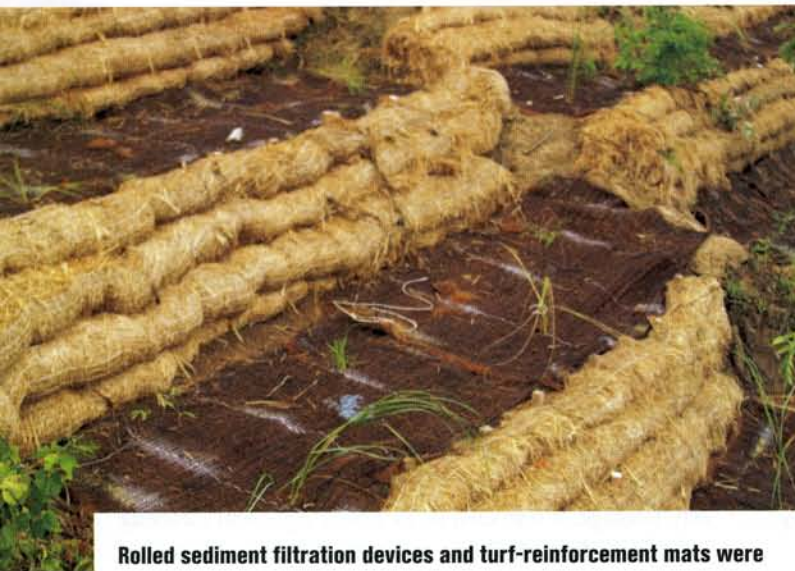
Rolled sediment filtration devices and turf-reinforcement mats were used to build and stabilize the terraces.

adjoining land. Coir logs and standard straw wattles were suggested but rejected based either on high cost or poor performance. Ultimately, the team selected North American Green’s SedimentSTOP, a rolled sediment filtration device, based on its ability to filter runoff water.
