**Geosynthetics solve
chronic lagoon system
slope failure**

Geosynthetic solution applied for chronic slope failure at water treatment lagoon system

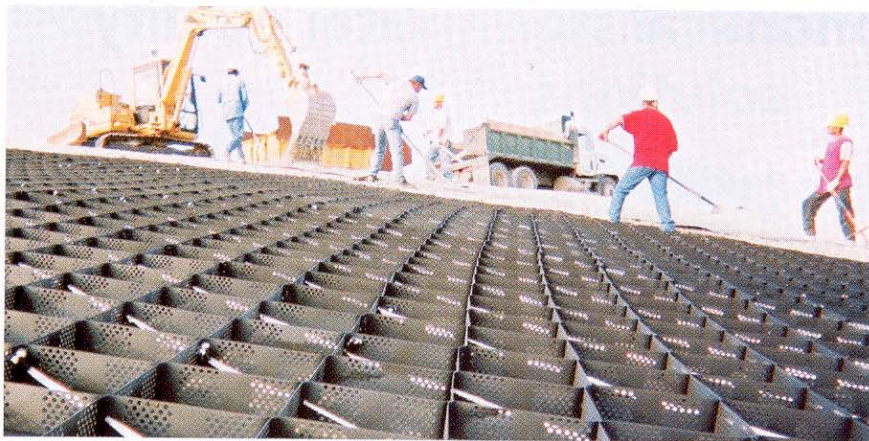
With the Geoweb® sections secured by integral tendons over an impermeable geomembrane, workers distribute aggregate infill in the cells.

The last step in the construction process was infilling the cells with crushed stone to provide the final cover for the protected slope. The contractor developed a conveyor system to expedite the infilling process. Over 1,500,000 ft² of geosynthetic materials were installed on this project.

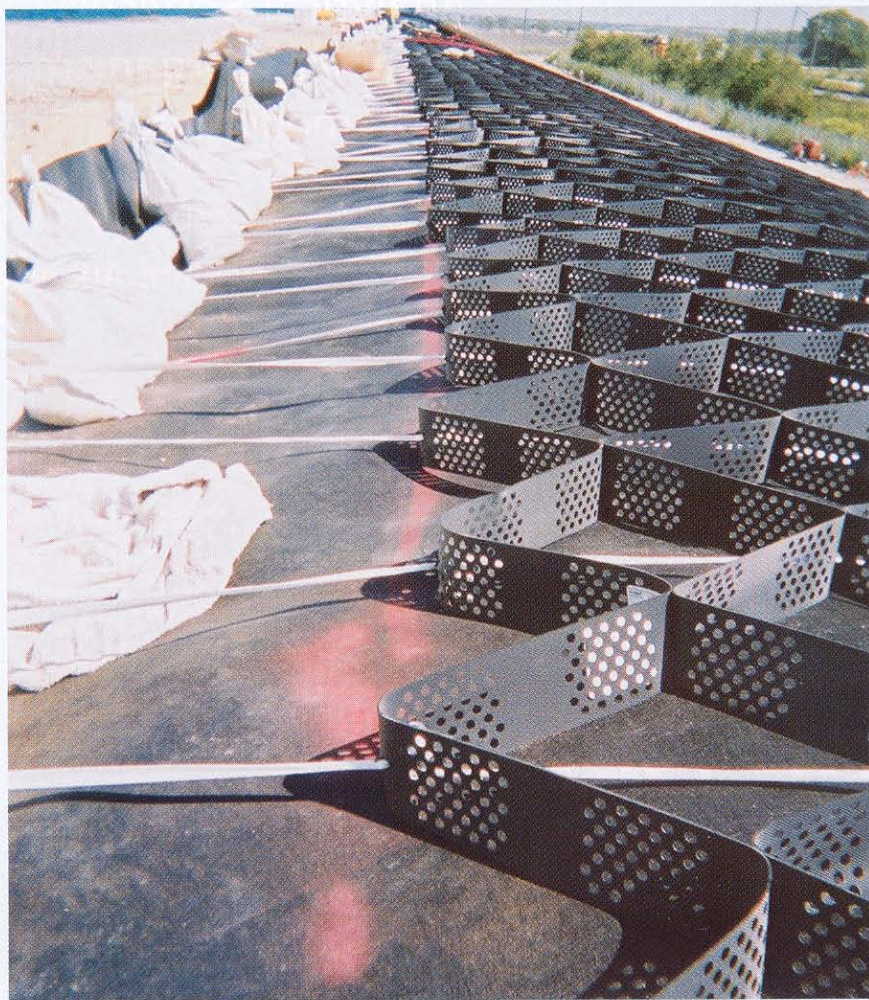
High-strength tendons, tied to a PVC pipe, allow the Geoweb® sections to be suspended over the containment lagoon's outside embankment.

strength tendons were secured to the pipe and threaded through the 4-inch deep geocell sections, then secured through the use of ATRA® restraint clips. The large cell size (18.7 in x 20.0 in), allowed installers to work efficiently on the 3H:1V slope, expanding, orienting, and then securing the geocell sections in place.

Anchored internal high-strength tendons and load transfer clips within the cellular structure create a suspended protective cover over the geomembrane, maintaining the liner's integrity by preventing puncture and natural degradation.

With the composite protective liner system in place, a 4-inch diameter, schedule 40 PVC pipe was placed in the trench at the top of the slope for the dead man anchor system. High-
