Clover Bar Ravine Clean Up, Edmonton, Alberta

Water Treatment

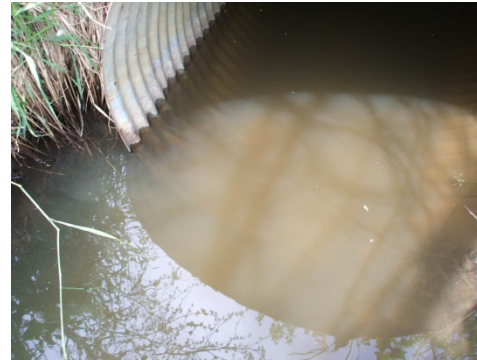
Left: Water before treatment with Floc Logs.

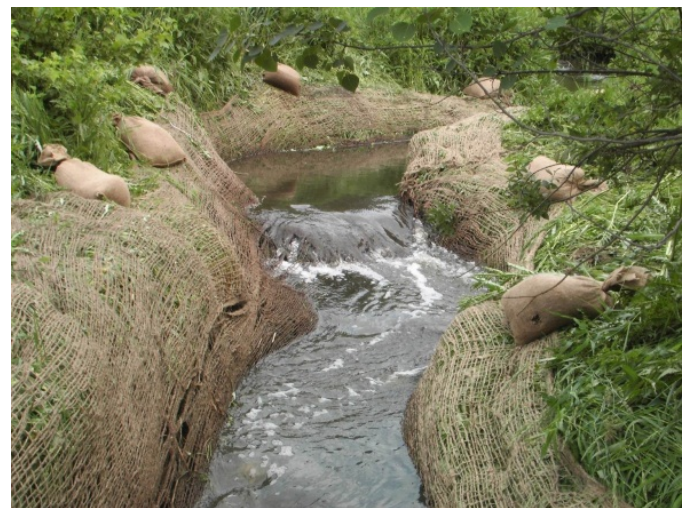
Below: Jute matting was installed along the stream bed and banks.

The passive treatment system was installed in June 2007. The treatment system was designed with 34 Floc Logs® placed along the creek bed beginning at the outfall. Before the logs were installed, the streambed was lined with an open-weave jute matting to prevent further erosion and work as an area of attachment for flocculated particulate. The logs were placed 10 feet apart alternating between APS 703d#3 and 706b Floc Logs®. Sand bags were placed in the channel and the Floc Logs® were tied off to them. The sand bags kept the logs in place as well as increased the turbulence of the water flowing over and around the logs, increasing mixing which in turn improved the reaction and performance of the system. The only maintenance required for this passive treatment system was simple monitoring of the banks to ensure they were not washing out. The biodegradable jute matting was not removed; new layers were simply applied directly on top of existing layers.

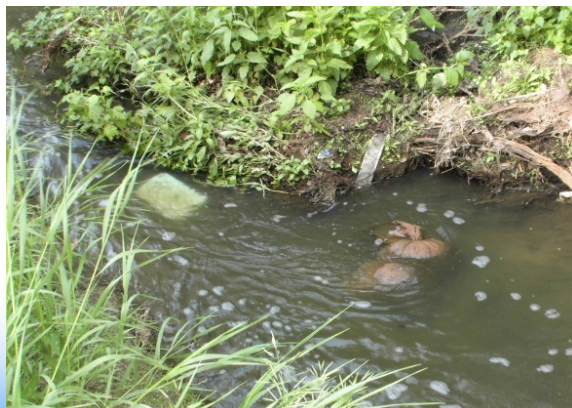
Left: Floc Logs were attached to sand bags, which added extra turbulence.

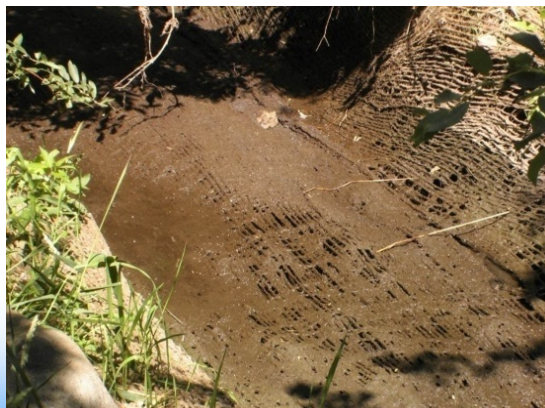
Right: Jute lining the creek bed and banks captured flocculated metals and sediment, preventing them from discharging into the stream and river.

These flocs are heavy and settle quickly out of the water column. Natural fiber matting, such as jute, is used in conjunction with Floc Logs® to provide an area of attachment for the polymer charged particles as well as added erosion control. Floc Logs® are composed of anionic, negatively charged, polyacrylamides. This charge repels against the negatively charged gill mucous of fish and other aquatic organisms, making them nontoxic even at high dosages and safe for use in the open aquatic environment, unlike cationic (positively charged) polyacrylamides or chitosan that can cause detrimental effects to aquatic organisms.

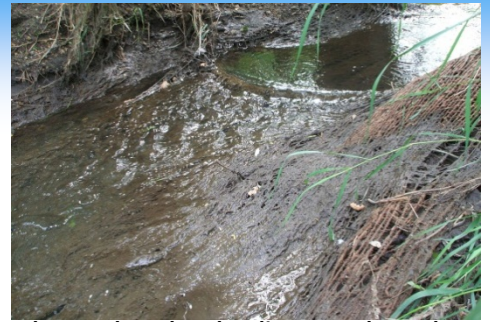
Above: Flocculated sediment and metals attached to jute matting result in clear water discharging from the treatment train.

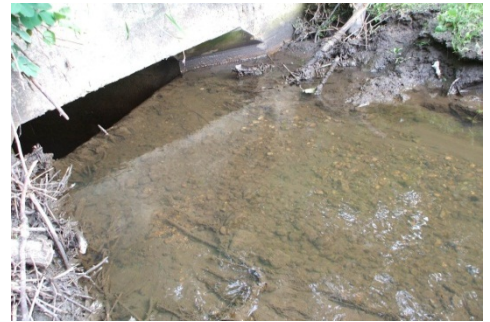
Above: Success is evident with clear water exiting.

Analysis of the water samples taken during treatment years showed a clear reduction in metals as well as total suspended solids (TSS) after the Floc Log system was installed. Water collected downstream from the treatment system showed dramatic reductions in TSS levels. Sampling revealed TSS levels as low as 4 mg/L and clear visibility to the bottom of the stream. Large concentrations of collected sediment were observed within the treatment system and sediment samples from the first site showed large concentrations of metals within sediment that had accumulated around the Floc Logs®. There was then a gradual decrease in metal concentrations moving further downstream in the treatment system. The passive treatment system achieved turbidity levels and metal concentrations limits that were established by the regulatory agencies. These results are proof positive that the implementation of the polymer enhanced passive treatment system was highly successful and the eco-friendly solution to reducing turbidity and metal contamination within the Clover Bar Ravine.
